**Hot/Wet Environmental Degradation
of Honeycomb Sandwich Structure
Representative of F/A-18:
Discolouration of Cytec FM-300
Adhesive**

DSTO-TN-0263

**Airframes and Engines Division
Aeronautical and Maritime Research Laboratory**

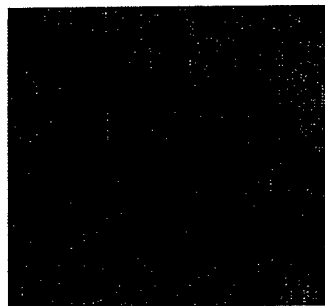
Figure 4 Characteristic colour: Colour of Cytec FM-300 adhesive in uncured off-the-shelf form.

The characteristic colour of Cytec FM-300 adhesive appears blue in the uncured off-the-shelf form as shown in Figure 4. Coloured dyes are added to the adhesive by the manufacturer to enable easy identification. When the adhesive is cured in air at the manufacturers recommended cure temperature of 175°C, the adhesive undergoes a colour change where the blue colour shown in Figure 4 changes to green. This may be caused by oxidation of the pigment in the adhesive. If the adhesive is cured in the complete absence of air, the adhesive does not undergo a colour change. The characteristic colour shown in Figure 4 merely loses its blue lustre and the general colour remains faded but blue as shown in Figure 5. During the manufacture of honeycomb sandwich panels, where the face-sheets are bonded onto the honeycomb core in an autoclave, the air contained in the honeycomb cells is sufficient to cause the adhesive to change colour. A thin film on the fillet adhesive changes colour to green as shown in Figure 6. The faded blue colour shown in Figure 5 is therefore only achievable if the adhesive is completely starved of air during curing, such as when cured between glass plates or when the adhesive is pinched between the panel face-sheet and the honeycomb. This cured but somewhat faded colour (Figure 5) of FM-300 adhesive achieved in the above way will be taken as the reference colour in this study. All changes in adhesive colour during this study will be compared to this reference colour.

The characteristic uncured colour of Cytec FM-300 adhesive shown in Figure 4 undergoes significant colour changes when exposed to various environmental conditions. During honeycomb sandwich panel manufacture, where the adhesive is cured for 60 minutes at 175°C, small quantities of air contained in the honeycomb cells causes a green discoloured film at the surface of the adhesive as seen in Figure 6. This green discolouration may be caused by oxidation of the pigment particles in the adhesive. When the adhesive is cured in the absence of air, such as when cured between two glass plates, the adhesive loses its original blue lustre and turns a dull blue but still maintains its general blue colour (as seen in Figure 5).

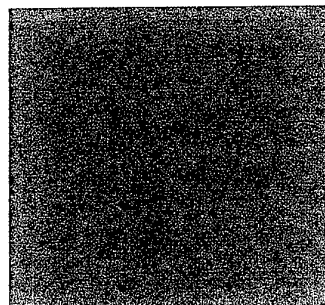
Figure 5 Reference colour: Colour of Cytec FM-300 film adhesive obtained when cured in the absence of air such as when cured between two glass plates.

Recording of specimen colour was conducted at time 4, 8, 16, 25 and 36 weeks. The colour of the specimens were scanned directly using a digital scanner. The image colour, contrast and brightness were enhanced on screen to resemble the colour state of the samples as closely as possible. The image was then printed and compared to the colour of the actual specimen. Where the required colour was unable to be produced using the scanner, an image of the specimen was taken using a digital camera. Although the colours were enhanced to represent the specimens closely as possible, it is recognised that the colours will undergo some change when transferred electronically from different computers and printers. The colours presented at Appendix A are therefore a close and not exact representation of the colours found in experiment. All changes in specimen colour were compared to the reference colour of FM-300 adhesive shown in Figure 5.

Progressive changes in colour of the specimens are shown in Appendix A for each exposure condition. The colour of FM-300 cured in the absence of air (as seen in Figure 5) is provided in each result set as a reference colour for comparison. Exposure conditions for both the edge exposure and surface exposure study are presented in Table 1 and Table 2 respectively. An example of the colour change experienced by FM-300 adhesive during the manufacturers recommended cure cycle is presented for reference in section 3.1.

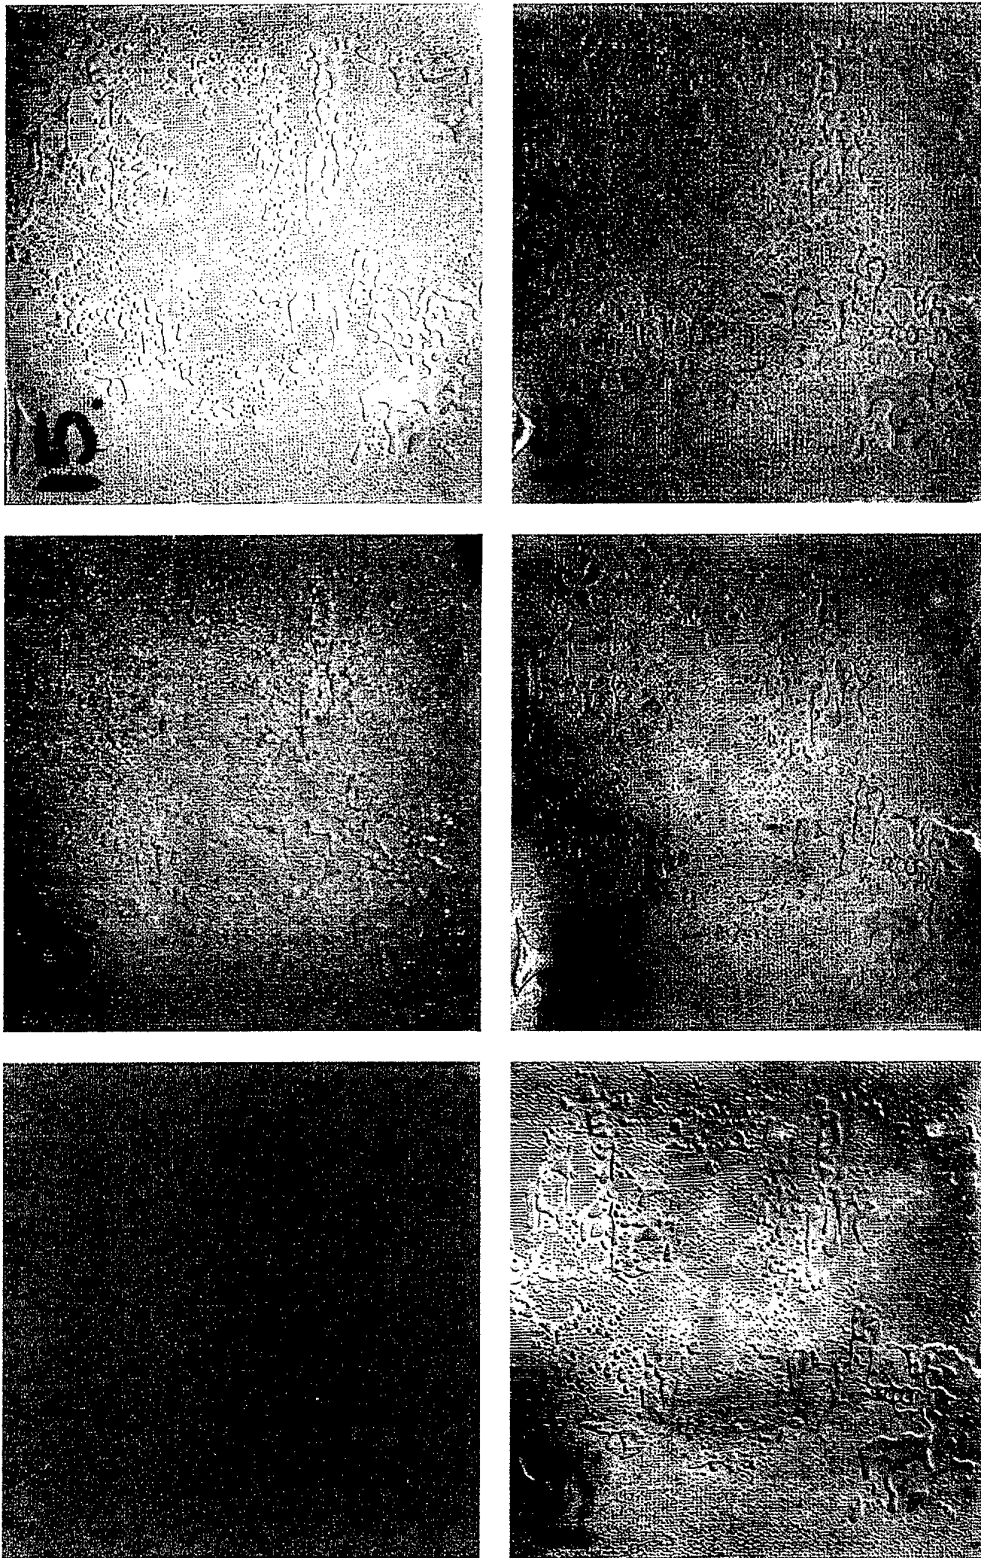
Plate # 15 Exposure to 80 °C, 95 % RH: (Clockwise from top left) Reference, 4 weeks, 8 weeks, 16 weeks, 25 weeks & 36 weeks.

Hot/Wet - 80°C, 95% RH Specimen 15 was conditioned in an environment at a relative humidity of 95% and a temperature of 80°C for a period of 36 weeks. The colour of this sample appeared quite different to that of both specimens 12 and 14. The specimen showed colour changes to that of a very light brown colour. The colour was seen to be non-uniform and patchy. The overall colour of the specimen, when compared to specimens 12 and 14, appeared to be a light green/brown colour. Some localised areas contained darker spots of brown. The entire surface colour appeared to be in a transition from light green/brown to a uniform light brown colour. Some areas of the surface appeared to be a very light green/white colour.

A significant observation was made when specimens 12 and 15 were compared. The colour of these specimens were completely different yet they were exposed to very similar conditions. The colour of specimen 12 appears light green/blue in colour with no brown content. Specimen 15 does not look blue and the overall colour appears to be a light green colour progressively changing to a brown colour. These two specimens were exposed to the same relative humidity of 95% but different temperatures. Specimen 12 was at a temperature of 70°C and specimen 15 at 80°C. It appears that the level of both temperature and humidity play a significant role in FM-300 adhesive discolouration. The appearance of specimen 15 suggests that changes in overall colour to brown first appear at a temperature of 80°C.

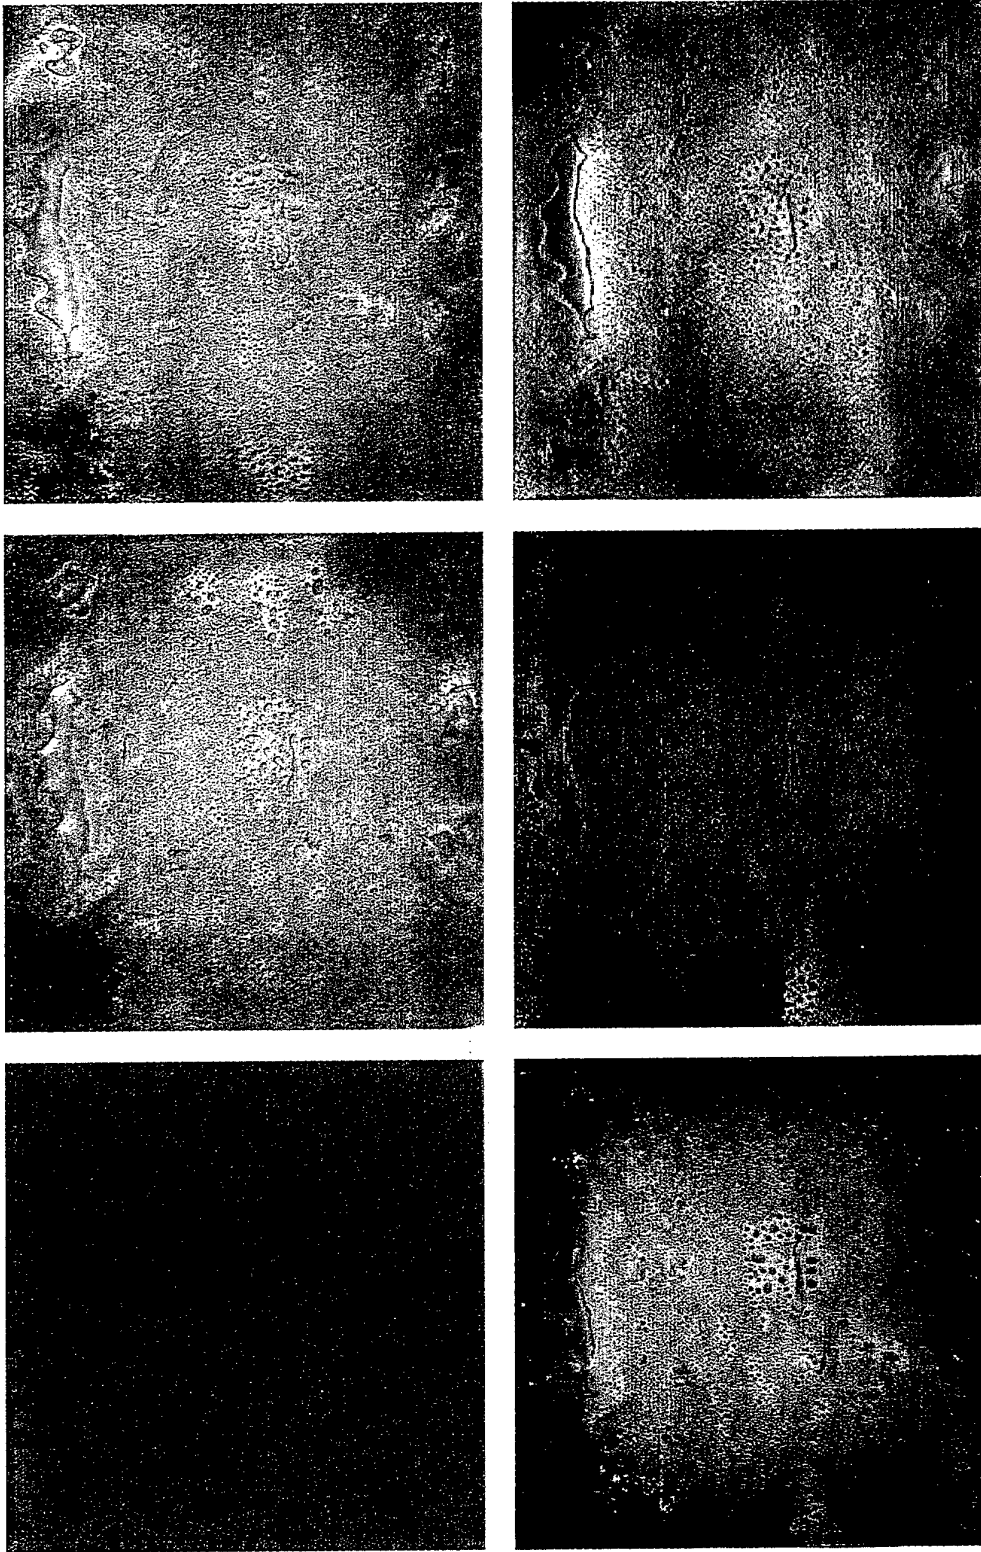
Plate # 16 Exposure Period to 90 °C, 95 % RH: (Clockwise from top left) Reference, 4 weeks, 8 weeks, 16 weeks, 25 weeks & 36 weeks.

Hot/Wet - 90°C, 95% RH Specimen 16 was conditioned in an environment at a relative humidity of 95% and a temperature of 90°C for a period of 36 weeks. There were only two colours seen on this specimen and this was light and dark brown. The light brown colour occupied the centre area of the specimen and resembled the brown colour seen on the AMRL-Q beam shown in Figure 1. The dark brown colour was seen along the edges of the specimen and was a very deep brown colour that occupied an area 10 millimetres wide along the edges of the specimen. This dark brown colour seemed to be spreading in towards the centre of the specimen. It appears that with time, the whole of the surface would become a uniform dark brown colour. The brown colours on the surface of this

specimen first appeared in a lighter shade after 16 weeks of exposure. The discolouration then intensified as time past from 25 to 36 weeks. The centre of the specimen always appeared lighter than the darker brown along the edges of the specimen.

Specimen 16 was the only specimen that produced colours similar to those colours seen on the AMRL-Q beam shown in Figure 1. At the exposure period of approximately 36 weeks, the light brown colour seen at the centre of specimen 16 was similar to the brown colour seen on the AMRL-Q beam. Beyond this period of exposure, the whole of the specimen began to take on a darker shade of brown. The edges of the specimen changed to a very deep brown and the centre appeared to be taking on this same dark shade of brown as time passed.

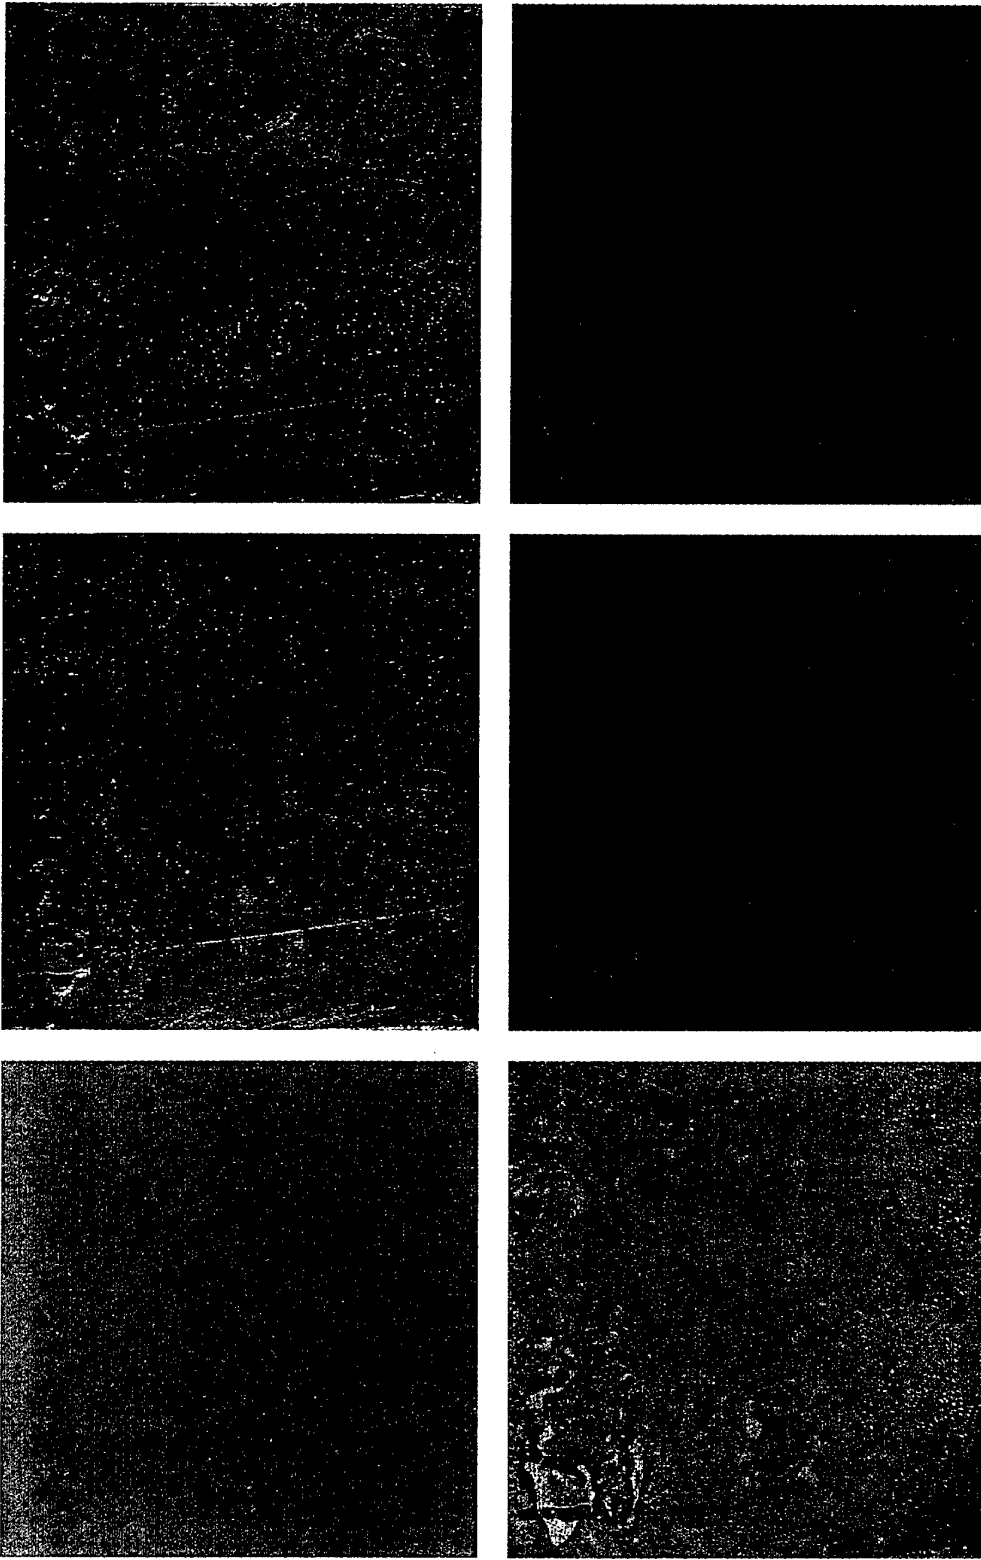
Plate # 17 Exposure Period to 90 °C, Dry : (Clockwise from top left) Reference, 4 weeks, 8 weeks, 16 weeks, 25 weeks & 36 weeks.

Hot/Dry - 90°C, 1.1% RH Specimen 17 was conditioned in an environment at very low relative humidity and a temperature of 90°C for 36 weeks. The colour was uniform across the specimen surface and appeared a light green/brown colour but more green than brown. Although the colour contained some brown, the overall colour did not resemble the colour of the fillet adhesive seen on the AMRL-Q beam. The colour was significantly different to that of specimens 12 and 14.
